IUGG, Melbourne 2 July 2011

# Accidents at Fukushima Daiichi Nuclear Power Plant caused by the Great Off Tohoku Earthquake of 11 March 2011

Kojiro Irikura

Kyoto University/Aichi Institute of Technology

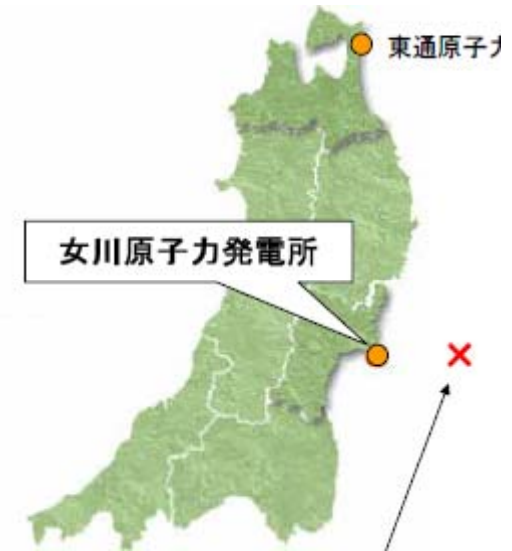
Comparison between recorded acceleration and design acceleration to the DBGM Ss on Base Mats at Units 1 – 3.

Loc. Of Seismometer (bottom floor of reactpr bld.)		Record			Max. response acceleration to the DBGM Ss (Gal)		
		Max. acc. (Gal)			NS	EW	UD
		NS	EW	UD			
Onagawa	Unit 1	540	587	439	532	529	451
	Unit 2	607	461	389	594	572	490
	Unit 3	573	458	321	512	497	476

○ Observed records were larger than design levels marked by ○.

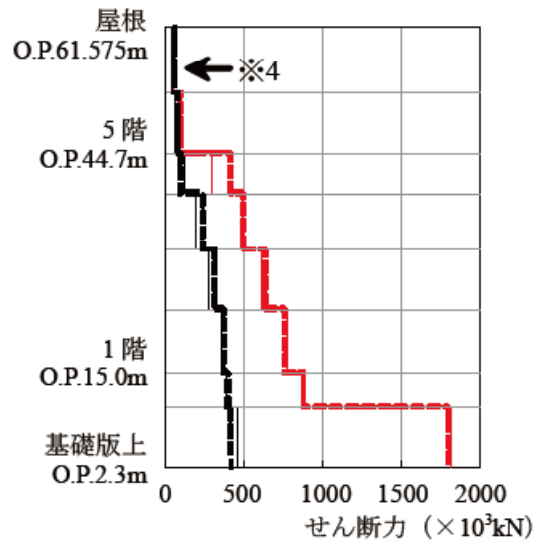
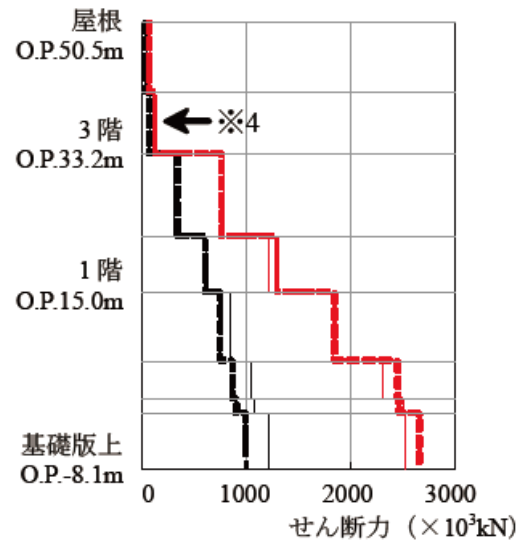
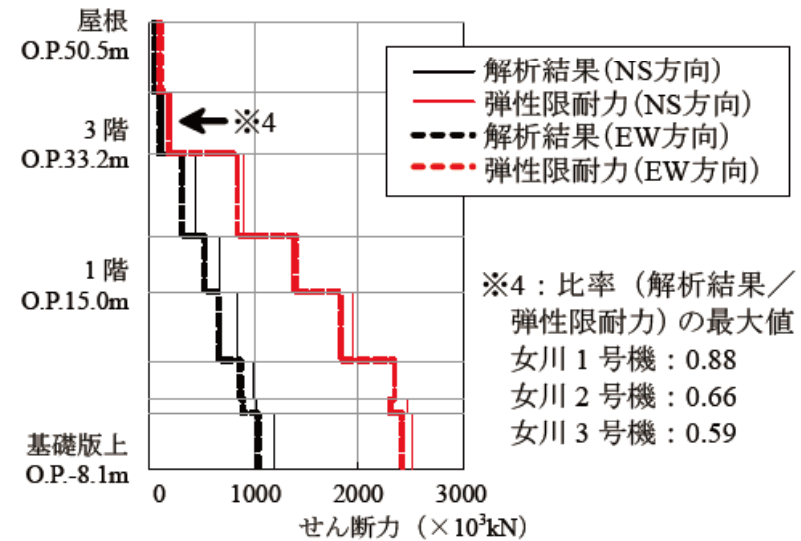
# Limit of shear stress acting on earthquake-resistant wall at each floor of the reactor building of the Onagawa NPP

Comparison between analyzed values from observed records and reference levels for seismic safety with respect to the maximum shear strain responses at the Onagawa NPP

解析結果	評価基準値 <sup>※3</sup>	(参考) 基準地震動 Ss
女川 1 号機	NS 方向	$0.36 \times 10^{-3}$	$2.0 \times 10^{-3}$	$0.65 \times 10^{-3}$
	EW 方向	$0.35 \times 10^{-3}$		$0.56 \times 10^{-3}$
女川 2 号機	NS 方向	$0.49 \times 10^{-3}$		$1.15 \times 10^{-3}$
	EW 方向	$0.28 \times 10^{-3}$		$0.55 \times 10^{-3}$
女川 3 号機	NS 方向	$0.81 \times 10^{-3}$		$0.99 \times 10^{-3}$
	EW 方向	$0.18 \times 10^{-3}$		$0.41 \times 10^{-3}$

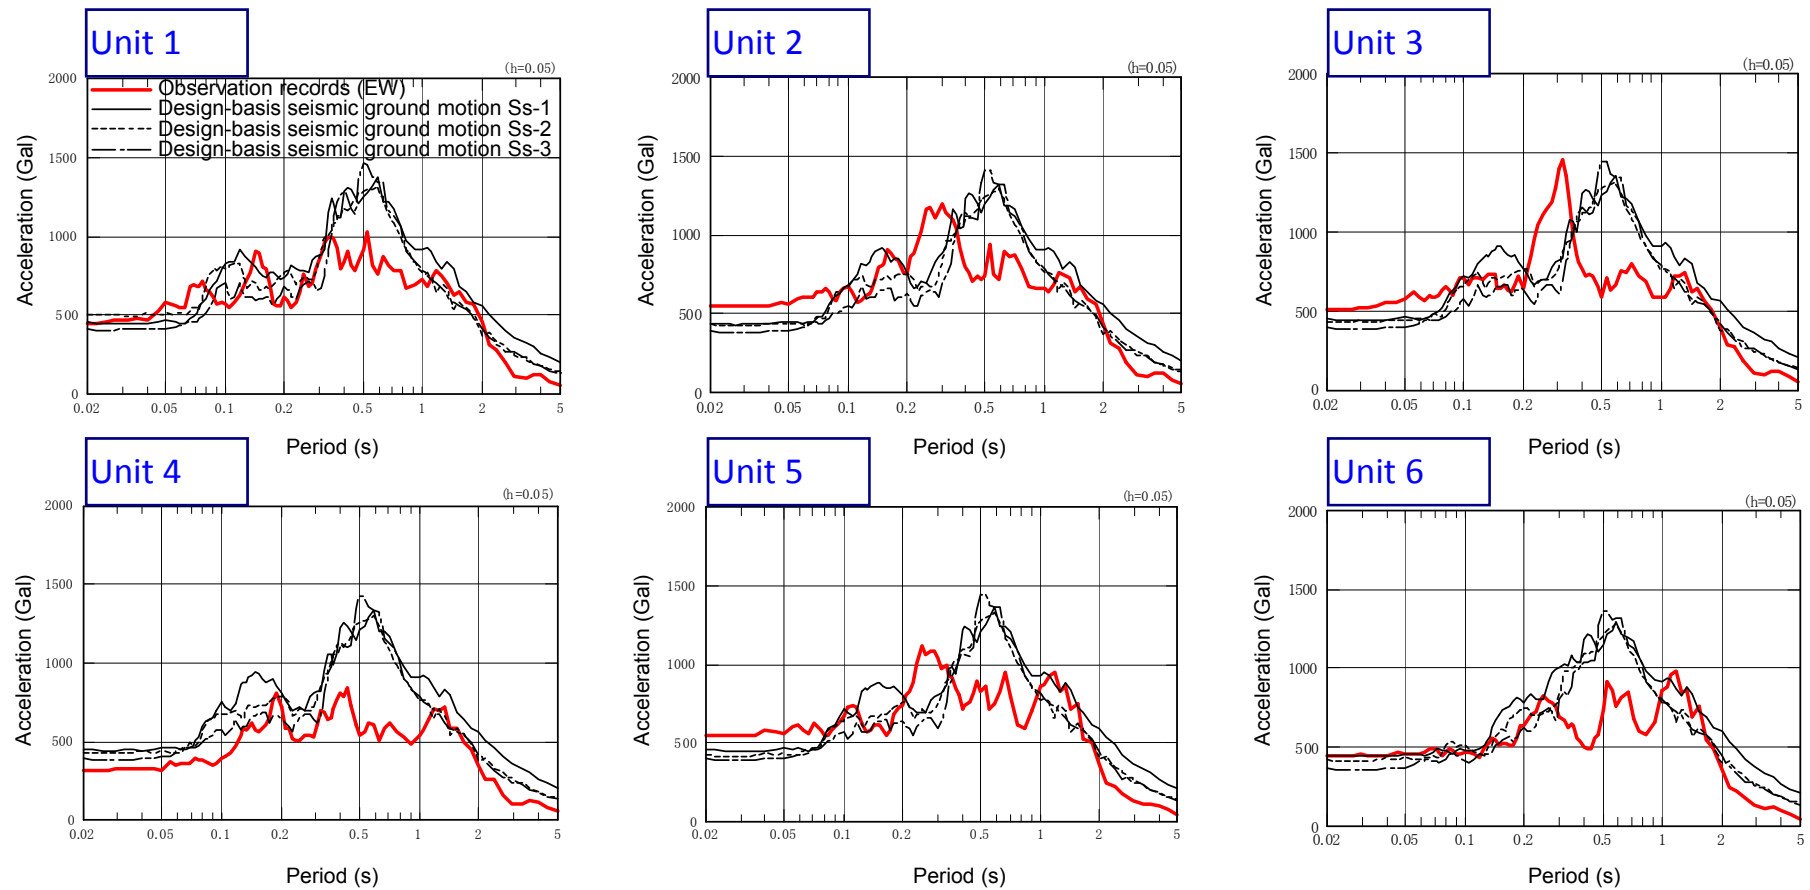
## ■ Comparison of response spectra calculated by observation records and design-basis seismic ground motion Ss

The response spectra of observation records were mostly the same as those due to design-basis seismic ground motion Ss, though they exceeded in some periodic bands.

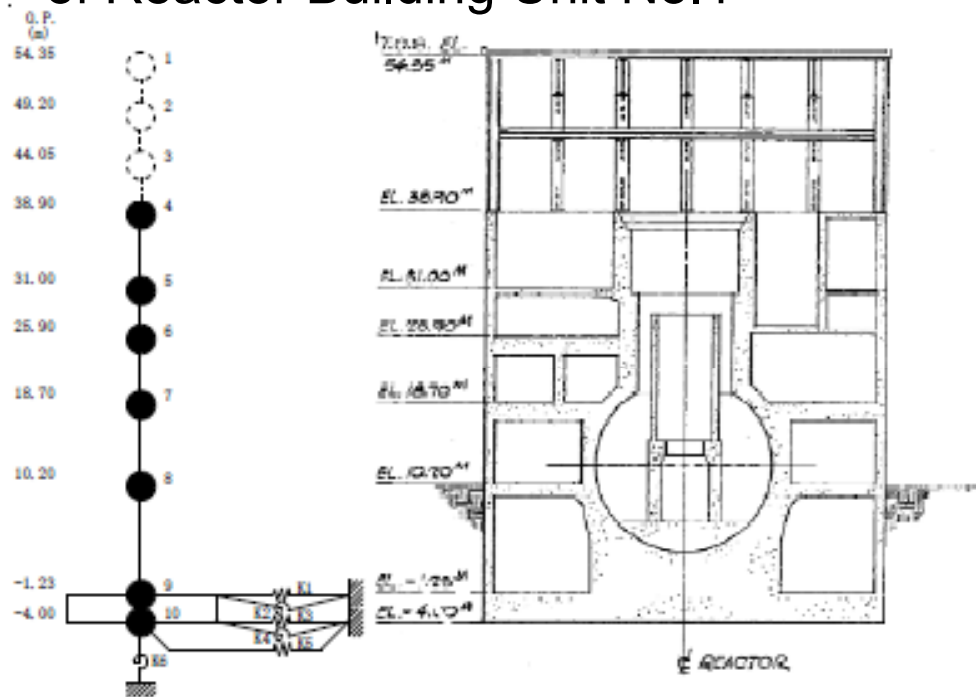
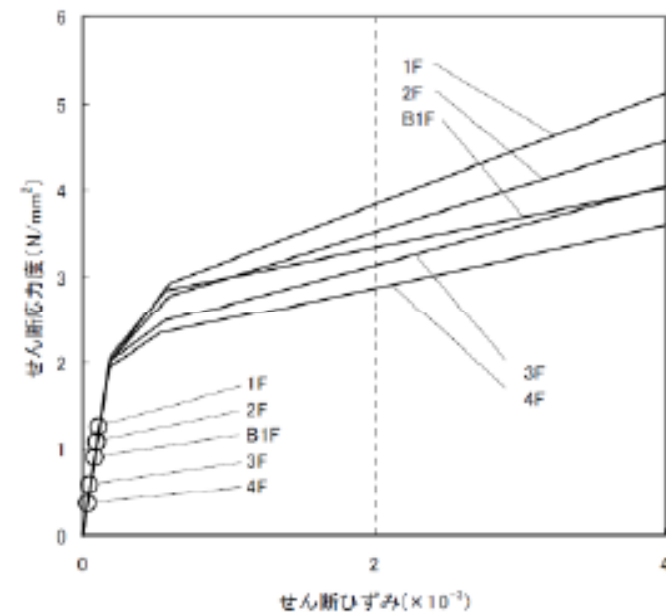
図1 1号機原子炉建屋 地震応答解析モデル  
(NS方向)

# Seismic Safety Evaluation for Reactor Building No. 1 at Fukushima Daiichi NPS during the Great Off Tohoku Earthquake

図2 せん断スケルトン曲線上の最大応答値  
(1号機、Ss-1、NS方向)

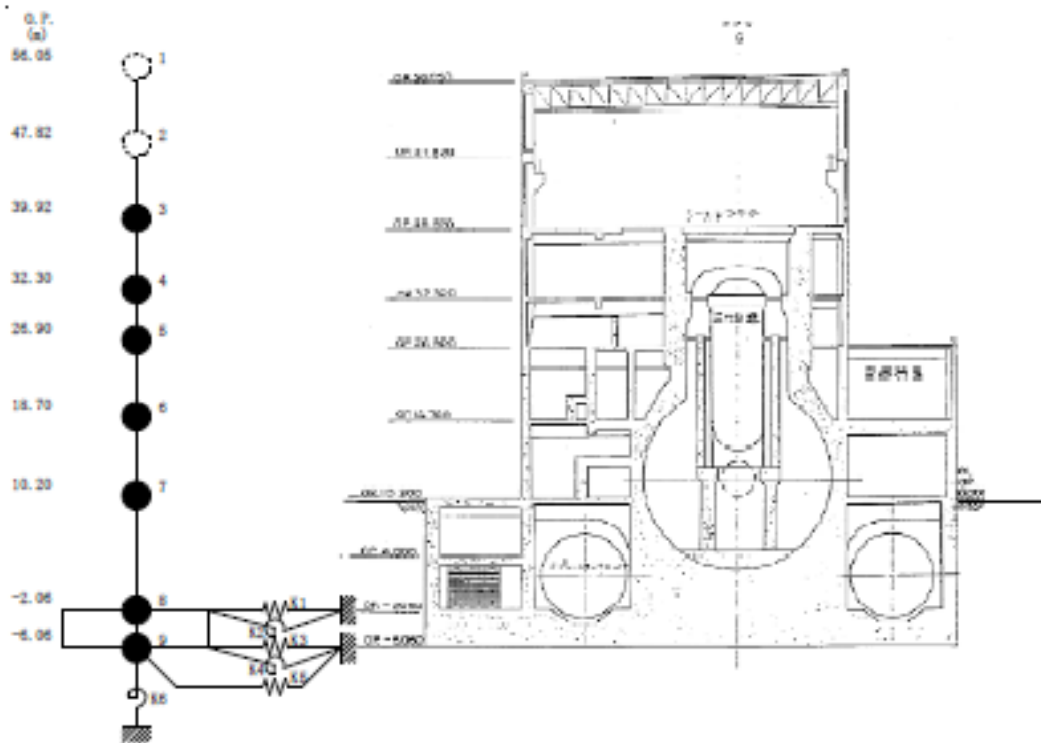
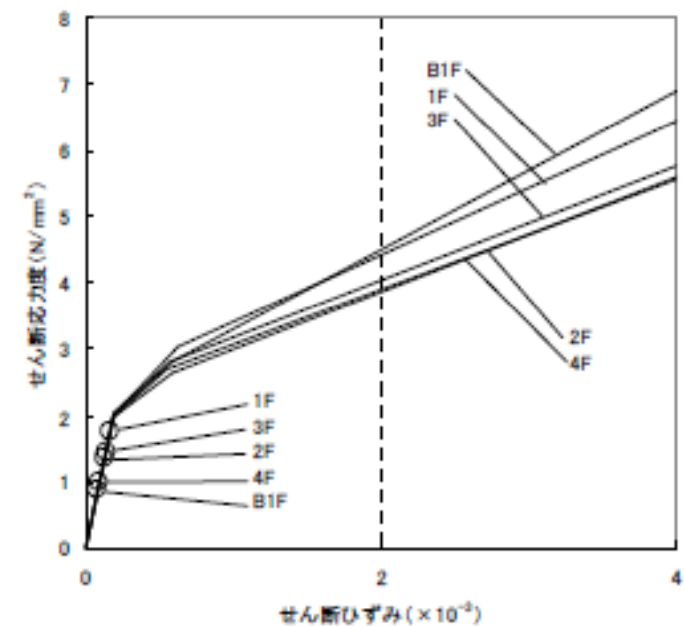
図3 4号機原子炉建屋 地震応答解析モデル  
(EW方向)

# Seismic Safety Evaluation for Reactor Building No. 4 at Fukushima Daiichi NPS during the Great Off Tohoku Earthquake

図4 せん断スケルトン曲線上の最大応答値  
(4号機、Ss-1、EW方向)

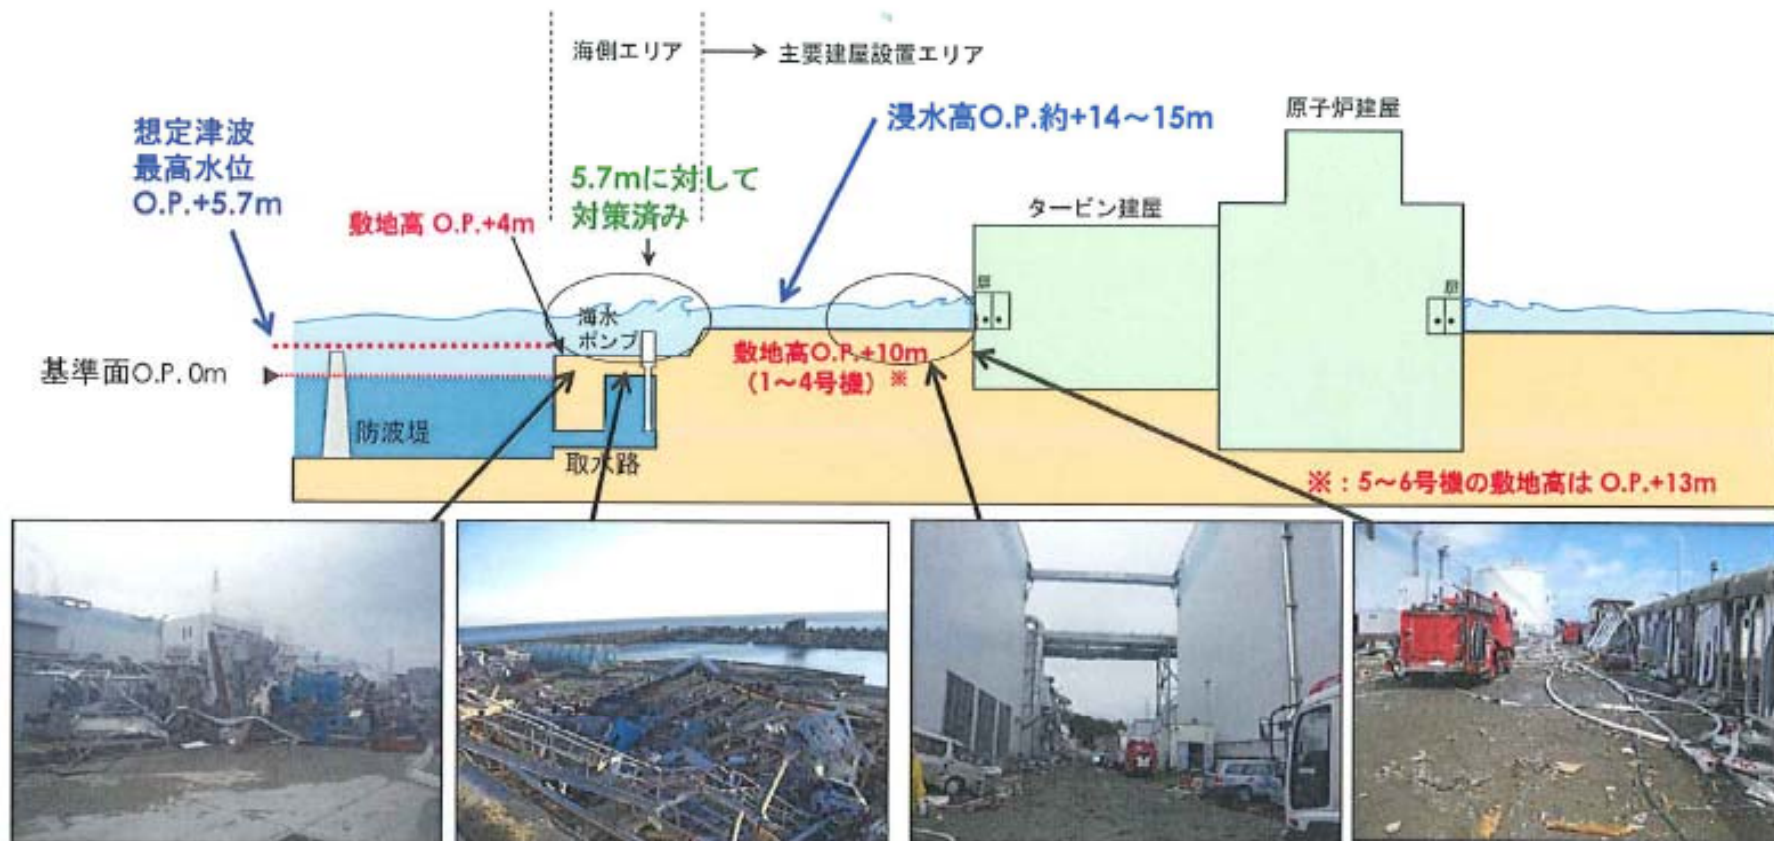
# Damage of Fukushima Dai-ichi due to the Tsunami During the Great Off Tohoku earthquake

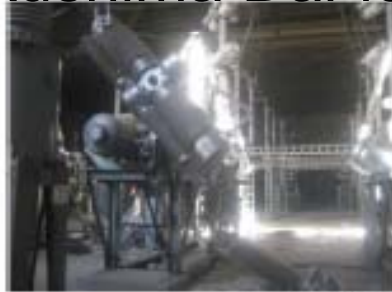
**Okuma line 1L (O-81)  
Circuit Breaker damaged**

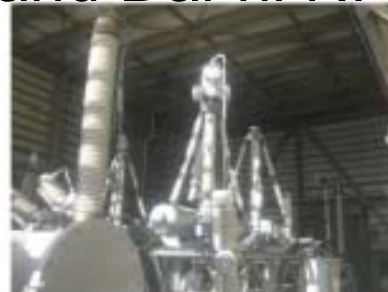
**Okuma line 2L (O-81)  
Circuit Breaker damaged**

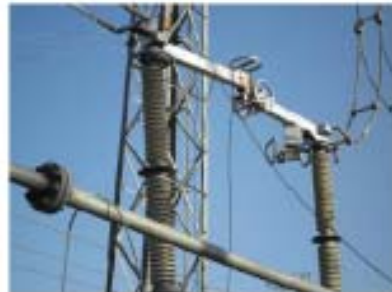
**Okuma line 3L, Ground wire  
(disconnected)**
