Flood risk from dike failure

Dr. László Nagy Technical University of Budapest, Hungary

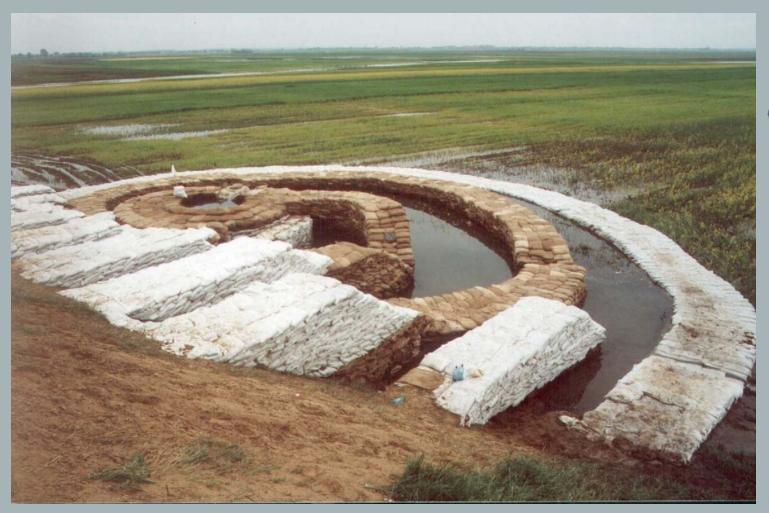
The largest piping in Middle-Europe Tiszasas

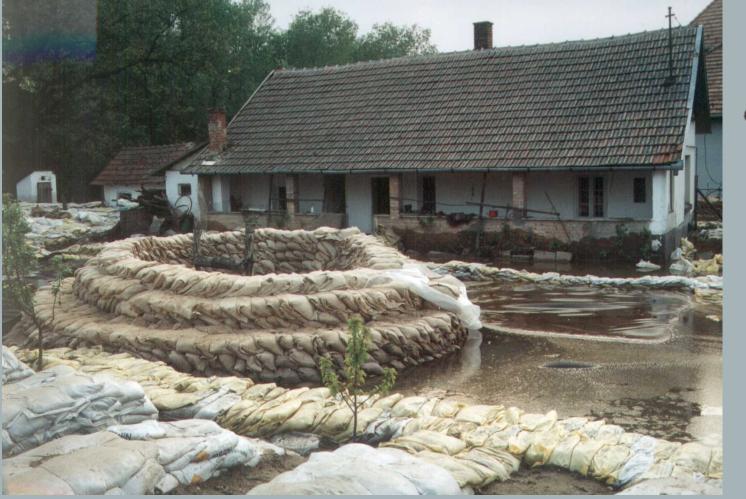
Piping in Nagyrév (at Tisza River)

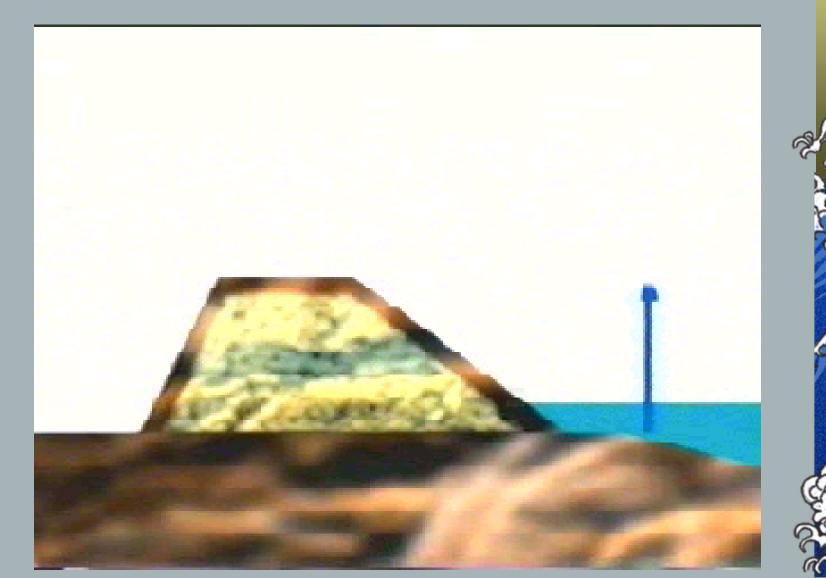
Levee breach, River Tisza right bank, Tarpa - Tivadar section

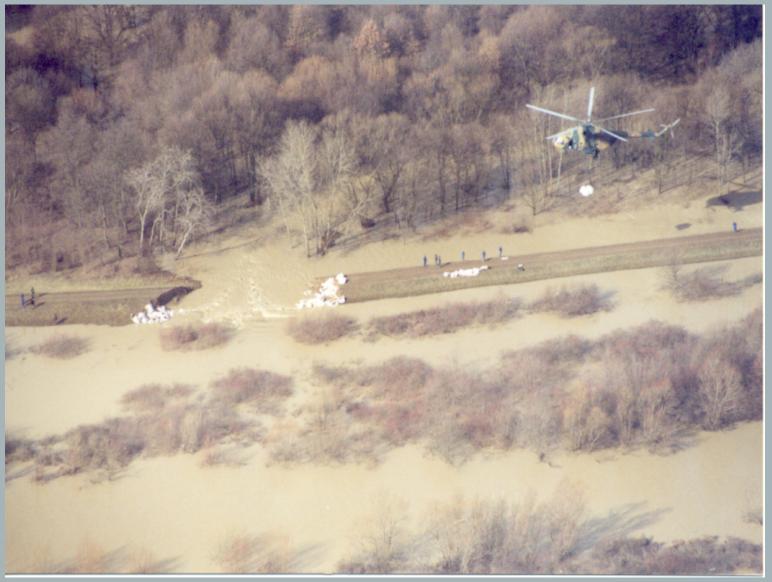
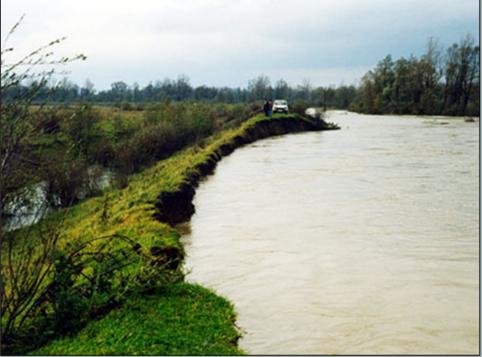
Dike breach management after failure in 2001

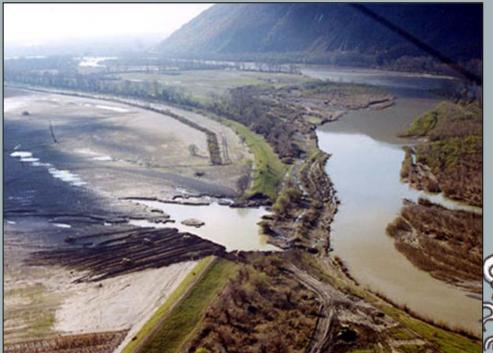
Dike breach management in Ukraine

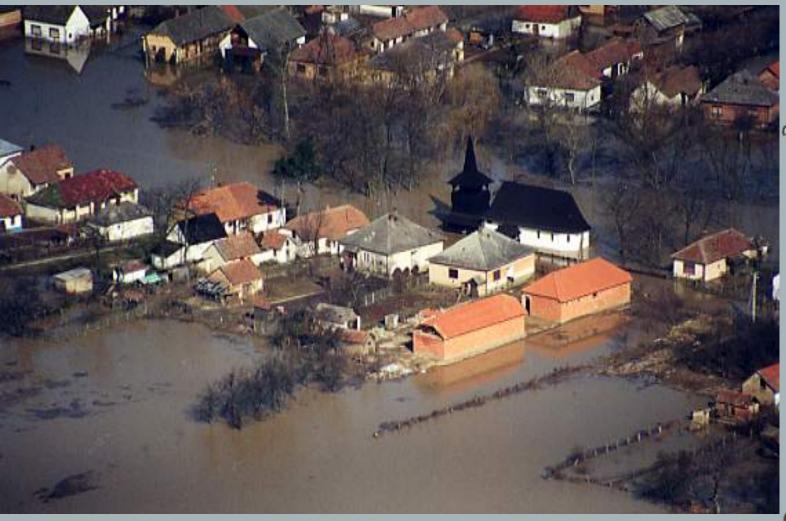
Inundation in Tákos (Hungary)
